Cambium Networks Cambium Networks, Inc. 3800 Golf Road Schaumburg, IL 60008, U.S.A.	Document Number	FSB 9075
	Revision	000v001
FIELD SERVICE BULLETIN cnPulse and PMP 450m sync issue in CambiumSYNC mode	Application	Global
	Effective Date	13 February 2019
	Expiry Date	N/A

SUBJECT: cnPulse does not support PMP 450m in drop-cable mode

MODEL / SYSTEM AFFECTED: cnPulse (C000000L066A) and PMP 450m

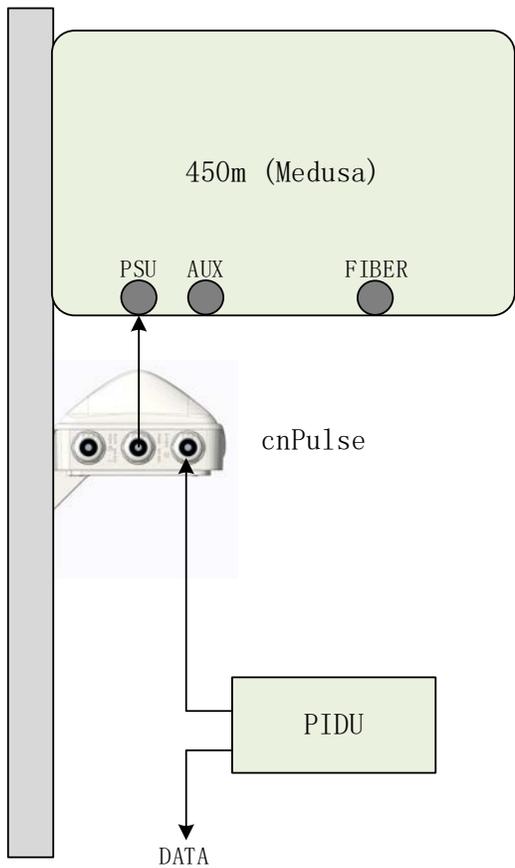
A GPS sync issue has been identified for customers who have received the new cnPulse GPS Sync devices when attempting to install with PMP 450m in CambiumSYNC mode. In most cases it takes a long time for the PMP 450m to lock onto the sync signal from the cnPulse device. cnPulse and PMP 450m are compatible when utilizing the AUX port or alternately utilizing a CMM5 device.

Incorrect Installation

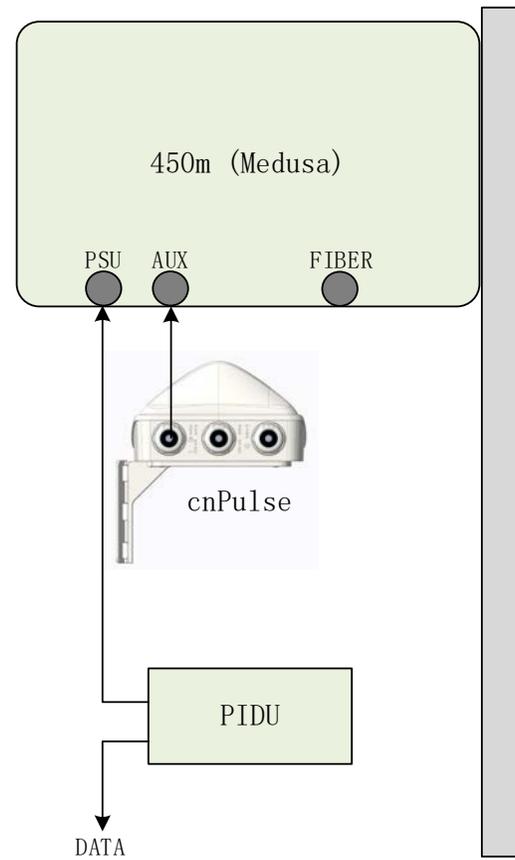
Correct Installation

It is highly recommended for all customers to install PMP 450m on cnPulse utilizing the auxiliary port.
