Cambium Networks Cambium Networks, Inc. 3800 Golf Road Schaumburg, IL 60008, U.S.A.	Document Number	FSB 9084
	Revision	000v001
FIELD SERVICE BULLETIN 3GHz PMP450m Access Point	Application	Global
	Effective Date	12 May 2021
	Expiry Date	N/A

SUBJECT: 3GHz PMP450m Access Points not able to provide power to cnPulse/uGPS connected via AUX-Port

MODEL / SYSTEM AFFECTED: All PMP450m Access Points within this ESN/MAC Address range '0A-00-3E-60-85-4D' to '0A-00-3E-60-8A-65' are potentially impacted.

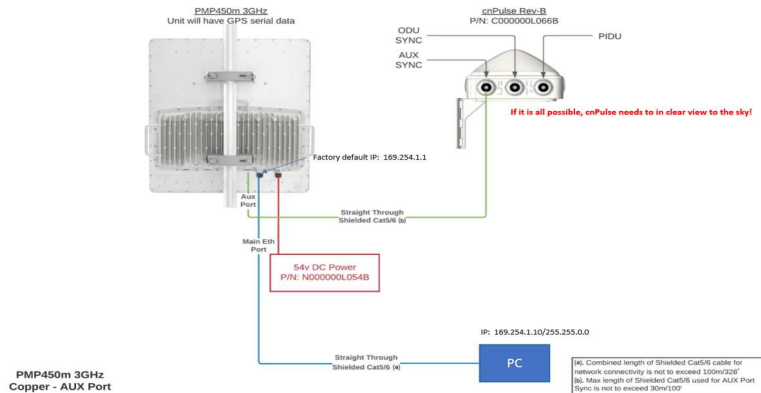
Fig-1: System under test network diagram – cnPulse

Symptom	Customers are reporting a symptom on the 3GHz PMP450m Access Points where a connected cnPulse/uGPS via its AUX-PORT has no sync or GPS data - GUI→ Home → Sync Status. Sync Status is in Searching, and GPS Data shows no Satellites information.
Current Status of Investigation	<p>We have identified a potential issue with some 3GHz PMP450m Access Points where they are not able to power up a cnPulse/uGPS device connected to their AUX port. If you are not using the AUX port of the 450m AP to power up cnPulse/uGPS, this issue will have no other impact. Cambium has determined that the units that are potentially impacted have ESN/MAC Address ranging from '<u>0A-00-3E-60-85-4D</u>' to '<u>0A-00-3E-60-8A-65</u>'.</p> <p>The procedure to screen the device to determine if the issue is present is described below. If you find that your unit is not performing as specified, please contact Cambium Technical Support to submit an RMA.</p>

1. **Configure, Fig.1:** Wiring and powering up the 3GHz 450m per Fig-1 above.
2. Configure a static IP address on the PC with 169.254.1.10/255.255.0.0 – the default factory IP/subnet mask for 3G PMP450m AP.
 - a. Launch a browser and access the 450m management UI at <http://169.254.1.1/>
 - b. Leave the Login/password entries blank (not required for this procedure)
 - c. Enable the Sync setting, from landing page after login: Configuration → General, as below:

3. **Verification** - Connect cnPulse to 3GHz PMP450m AP Aux-port per Fig-1.
 - a. If the LED is blue around the cnPulse's Aux Sync port, then the 3GHz PMP450m AP is providing power to cnPulse and unit is working as expected.
 - b. If the LED is **not** blue around the cnPulse's Aux Sync Port, then the 3 GHz PMP 450 AP is impacted. **Please follow Cambium Networks RMA procedures.**
