Cambium Networks™ 2000 Center Drive, Suite East A401 Hoffman Estates, IL 60192 USA	Document Number	FSB 9092
	Revision	001v000
FIELD SERVICE BULLETIN Wi-Fi 5 and Wi-Fi 6/6E Access Points incorrectly programmed with static IP address rather than factory default DHCP mode.	Application	Global
	Effective Date	12 April 2024
	Expiry Date	N/A

SUBJECT: Wi-Fi 5 and Wi-Fi 6/6E Access Points incorrectly programmed in the factory with a static IP address of 192.168.0.1 rather than default DHCP mode.

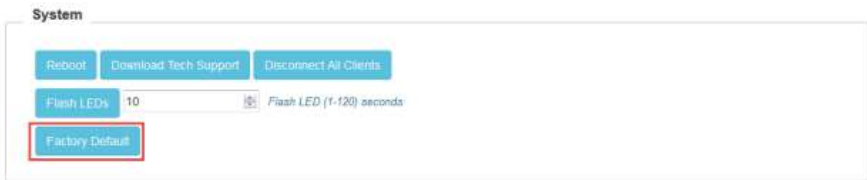
Symptom	<p>Access Points (APs), when initially powered up and connected to the network, will not obtain an IP address via DHCP and the AP will appear to be non-responsive. However, the AP has a static IP set and will respond to 192.168.0.1 IPv4 Address.</p> <p>Due to this issue, Zero-touch operation may not work as the AP may not be able to connect to Cambium’s cnMaestro Management system (Cloud and On-Premises).</p>
Current Status of Investigation	<p>Programming at the factory has been corrected, however, this bulletin addresses the units that have been sold to customers that are affected.</p>
Resolution	<p>To return the unit to DHCP mode, it is recommended to factory reset the AP. A factory reset can be performed by locating the reset button on the AP located near the ethernet port. With the AP powered up, press and hold the reset button for 15 seconds or more. Once this is completed, the AP will have the default setting set to DHCP and you can continue with the deployment of the AP.</p> <p>If the AP is already deployed and is not easy to physically access, the recommendation is to log into the AP UI using IP address 192.168.0.1, login using the default credentials admin/admin and factory default the AP (from the Operations menu item):</p>

<p>Alternately, user can change the default setting from “Static IP” to “DHCP”. Once logged into the AP, go to Network->VLAN and open either “IPv4” or “IPv6”. From there, change the Address field from “Static IP” to “DHCP”. Once this is completed, you can continue with the deployment of the AP.</p> <p>If assistance is needed, Cambium Technical Support can be contacted at: https://www.cambiumnetworks.com/support/contact-support</p>
